**Flood Control Project Maintenance  
Levee Inspections**  
**LMA District Cover Sheet**  
**Spring 2018 Levee Inspection Results**

**Reclamation District No. 0900 West Sacramento**

**Spring 2018 Levee Inspection Results**

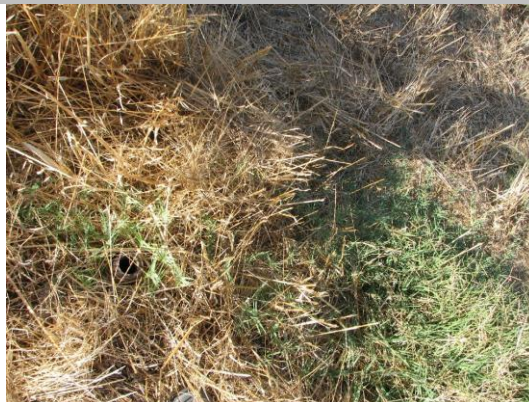
Photo 2 of 3 : UCIP\_SP\_2018\_37665\_68375.jpg

Air vent visible through dense vegetation.

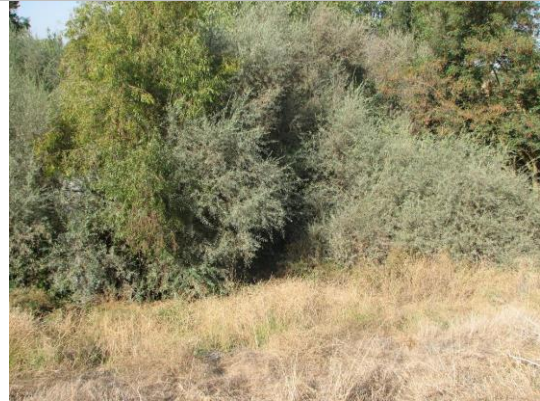
Photo 3 of 3 : UCIP\_SP\_2018\_37665\_68374.jpg

LM Start	2.15	Rating **	M	Issue No.	356 (cont)
LM End	2.15	Issue Type +	En	Location *	
Category	Supplemental			GPS Latitude/Longitude	
				Start	End
Item	DWR UCIP Field Study			38.556994 °	38.556994 °
				-121.516843 °	-121.516843 °
DWR ID					
Comment Code					
Inspector Comment					
FS_ID:37665 DS_ID:17772 EP_NO: N/A Repair Type: Non-Urgent Crossing Status: Found UCIP Comments: Dense vegetation limits the inspector's visibility to identify signs of pipe failure (leaks) along the slope. Recommend removing vegetation along pipe alignment to conduct proper inspection of structure and appurtenances. FIELD_STRUCT_DESC: 42-inch drainage pipe of unknown material through the levee, 21.5 feet below the levee crown. Slide gate in concrete riser on the waterside (WS) slope. Flap gate on the WS end. [Additional Reference(s): DWR Levee Log, 2003] FS Date: 10/6/2009

Dense vegetation along landward side.

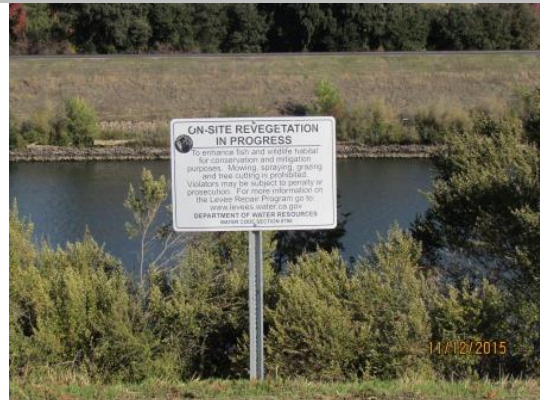
Photo 1 of 1 : SP\_2018\_RD0900\_230\_17\_20180301\_00009.jpg

LM Start	2.26	Rating **	A/W	Issue No.	17
LM End	3.72	Issue Type +	Ma	Location *	WS
Category	Earthen Levee			GPS Latitude/Longitude	
				Start	End
Item	Vegetation			38.555304 °	38.536946 °
				-121.516127 °	-121.519774 °
DWR ID	DWR_RD0900_01_s_2012_17				
Comment Code					
V8 : Environmental Requirements.					
Inspector Comment

View of the DWR environmental mitigation site.

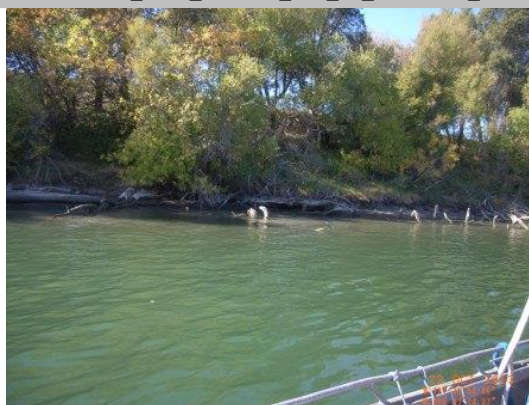
Photo 1 of 1 : SP\_2018\_RD0900\_230\_10\_20180301\_00006.jpg

LM Start	2.35	Rating **	M	Issue No.	10
LM End	2.47	Issue Type +	Ma	Location *	WS
Category	Supplemental			GPS Latitude/Longitude	
				Start	End
Item	2015 USACE Erosion Survey, DRAFT			38.554277 °	38.552504 °
				-121.515263 °	-121.514752 °
DWR ID	DWR_RD0900_01_s_2016_10				
Comment Code					
Inspector Comment					
2007 - Have good berm width with minor toe erosion. Close to the levee toe protection, but levee slope is steep. 2011 - New large erosion pocket. 2012 - Minor new erosion at the toe. 2015: No observed changes. [2015 Site ID: SAC_56-7_R]

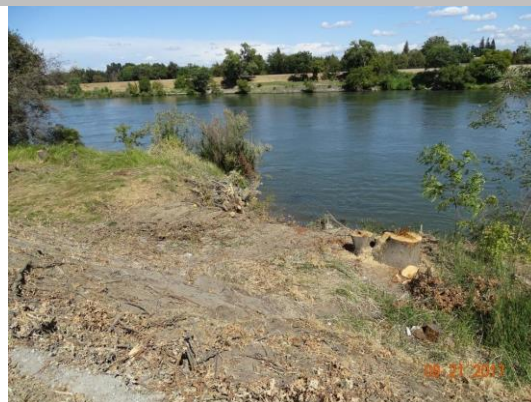
Photo 1 of 2 : SP\_2018\_RD0900\_230\_57\_20180301\_00012.jpg

LM Start	2.57	Rating **	A/W	Issue No.	57
LM End	2.57	Issue Type +	Ob	Location *	WS
Category	Earthen Levee			GPS Latitude/Longitude	
				Start	End
Item	Erosion / Bank Caving			38.550965 °	38.550965 °
				-121.514795 °	-121.514795 °
DWR ID	DWR_RD0900_01_f_2017_57				
Comment Code					
E1 : Note and monitor erosion site.					
Inspector Comment					
The contractor (AECOM) is constructing the setback levee, and they cut down the trees in this area. They are planning on putting some riprap on this erosion site soon.

View of the existing erosion site on the waterside berm of the levee. Fall 2017

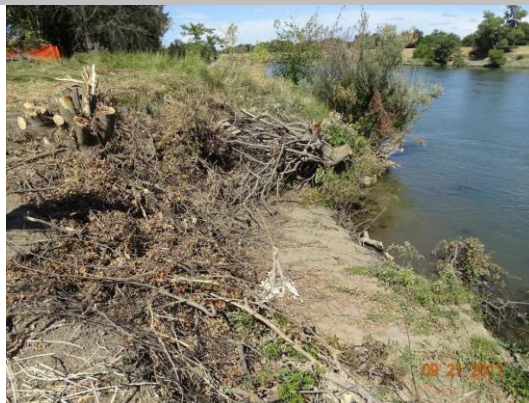
Photo 2 of 2 : SP\_2018\_RD0900\_230\_57\_20180301\_00013.jpg

The contractor is planning on placing riprap in this area. This picture was taken from the waterside berm of the levee looking upstream. Fall 2017

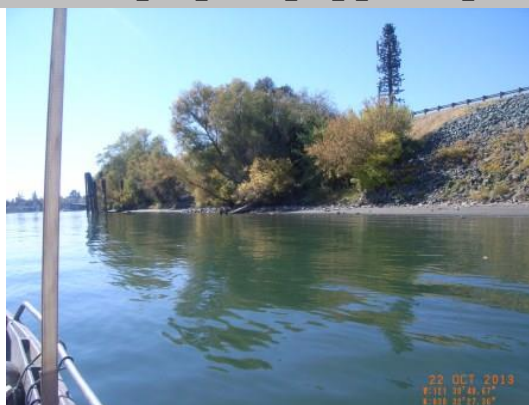
Photo 1 of 1 : SP\_2018\_RD0900\_230\_2\_20180301\_00002.jpg

LM Start	3.27	Rating **	M	Issue No.	2
LM End	3.48	Issue Type +	Ma	Location *	WS
Category	Supplemental			GPS Latitude/Longitude	
				Start	End
Item	2015 USACE Erosion Survey, DRAFT			38.541246 °	38.538689 °
				-121.513561 °	-121.515916 °
DWR ID	DWR_RD0900_01_s_2016_2				
Comment Code					
Inspector Comment					
2008 - Erosion into levee toe. Over steepened levee slope, worst at the upstream end. 2009 - Near vertical banks from rotational slumping, hidden by vegetation. 2010 - Boat sinking more, may be causing eddy scour around it. Difficult to see the vertical slumps due to dense vegetation. 2011 - Minor new erosion at the toe. The paddleboat that was sitting at this site for years has been removed. 2012 - Site extended upstream due to additional erosion. 2015: No observed changes. [2015 Site ID: SAC 55-7 R]

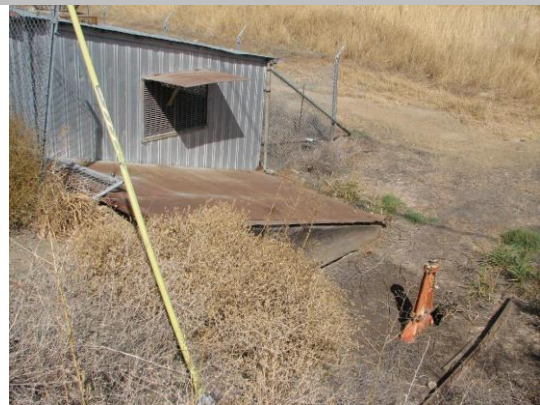
Photo 2 of 3 : UCIP\_SP\_2018\_37668\_68390.jpg

Pump house located on landward side.

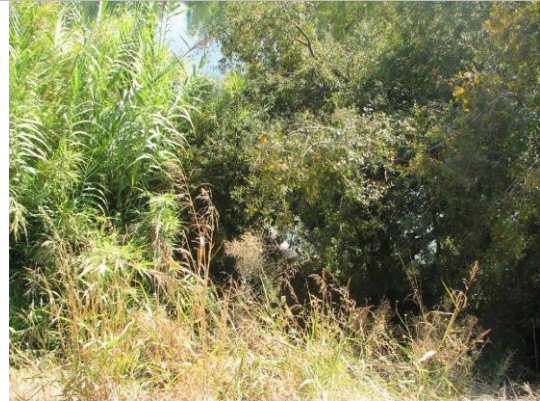
Photo 3 of 3 : UCIP\_SP\_2018\_37668\_68389.jpg

Comment Code						
Inspector Comment						
FS_ID:37668 DS_ID:17769 EP_NO: N/A Repair Type: Non-Urgent Crossing Status: Found UCIP Comments: 02/26/2018 Pipe is located within the construction limits of the Levee Improvement Project for RD0900, As-builts PENDING Project Completion. -- UNDER CONSTRUCTION Levee Improvement Project, construction schedule Summer 2016 to November 2018. Levee improvements address through seepage, underseepage and slope stability and include strengthen-in-place improvements and construction of a setback levee. Reference: [Issued FOR CONSTRUCTION] West Sacramento Area Flood Control Agency Southport Levee Improvement Project Early Implementation Program. Southport Sacramento River Levee: (Stat 3+90 to Station 287+57). Volume 3 (W.O. # 41164) December 2016 Conformed Submittal. HDR Engineering Inc. Folsom, CA – (DWR UCIP – O. Magana) 10/06/2009 Dense vegetation limits the inspector's visibility to identify signs of pipe failure (leaks) along the slope. Recommend removing vegetation along pipe alignment to conduct proper inspection of structure and appurtenances. (DWR UCIP - O. Magana) FIELD_STRUCT_DESC: 24-inch pipe through the levee, 22.0 feet below the crown. Pump house at the landside (LS) toe. Screw gate in LS of the levee. Additional Reference(s): USACE Sacramento O&M Manual Unit No. 116, August 1955, revised 2011, (USGS River Mile [RM] 55.65), As-built drawing# 6-13-1100 page 3, January 1933] FS Date: 10/6/2009

Pipe visible on waterward side visible through dense vegetation.

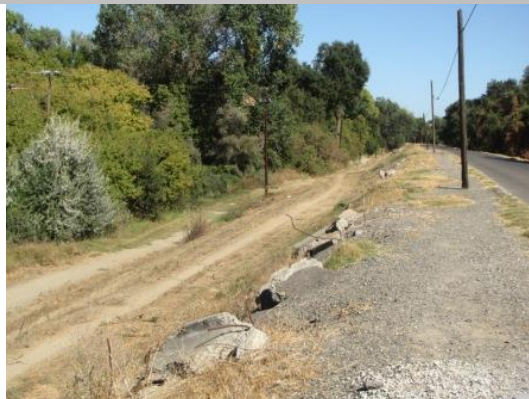
Photo 1 of 1 : SP\_2018\_RD0900\_230\_54\_20180301\_00011.jpg

View of concrete debris with metal looking upstream.

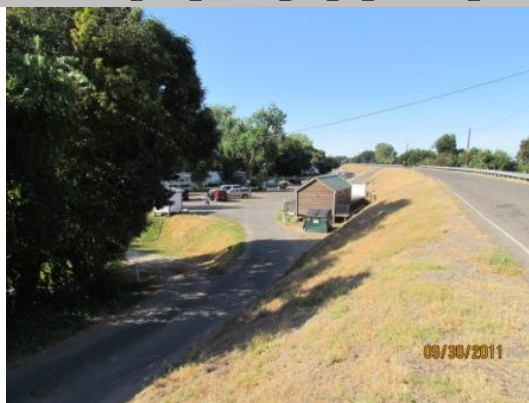
Photo 1 of 1 : SP\_2018\_RD0900\_230\_20\_20180301\_00010.jpg

LM Start	4.26	Rating **	U	Issue No.	20
LM End	4.26	Issue Type +	En	Location *	WS
Category	Earthen Levee			GPS Latitude/Longitude	
				Start	End
Item	Encroachments			38.533274 °	38.533274 °
				-121.528628 °	-121.528628 °
DWR ID	DWR_RD0900_01_s_2012_20				
Comment Code					
BU : Building					
Inspector Comment					
Miscellaneous unpermitted encroachments at the Sherwood Harbor. An encroachment permit application is being reviewed by RD900.

View of Sherwood harbor's unpermitted properties on the waterside of the levee. The picture was taken from the crown looking upstream.

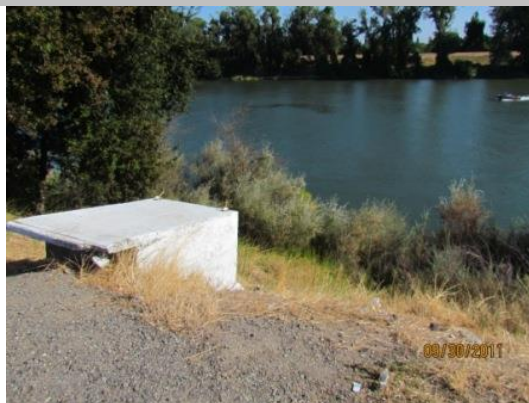
Photo 1 of 1 : SP\_2018\_RD0900\_230\_330\_20180301\_00016.jpg

Concrete anchor was found on the waterside slope of the levee looking upstream.

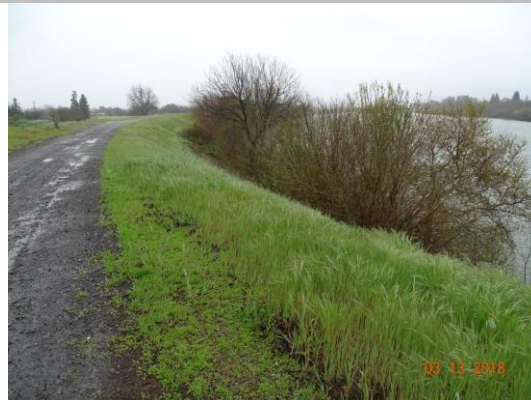
Photo 1 of 1 : SP\_2018\_RD0900\_230\_24\_20180314\_00024.jpg

Vegetation waterside looking north.

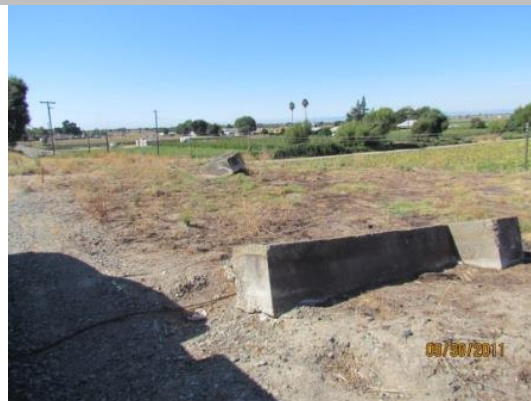
Photo 1 of 1 : SP\_2018\_RD0900\_230\_343\_20180301\_00017.jpg

Concrete debris from old rail road track was found on the landside of the levee looking upstream.

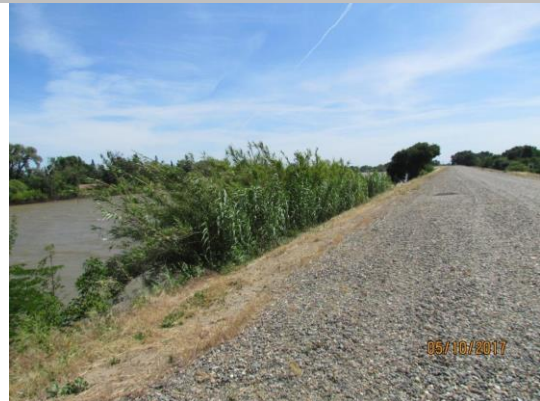
Photo 1 of 1 : SP\_2018\_RD0900\_230\_59\_20180301\_00014.jpg

View of the arundo on the waterside of the levee during spring 2017 inspection.

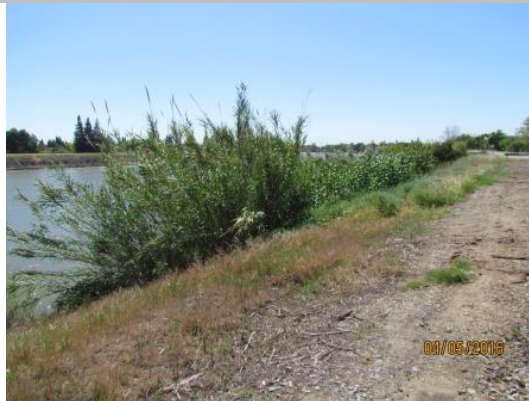
Photo 1 of 2 : SP\_2018\_RD0900\_230\_15\_20180301\_00007.jpg

Updated picture of the arundo on the waterside of the levee during spring 2016 inspection.

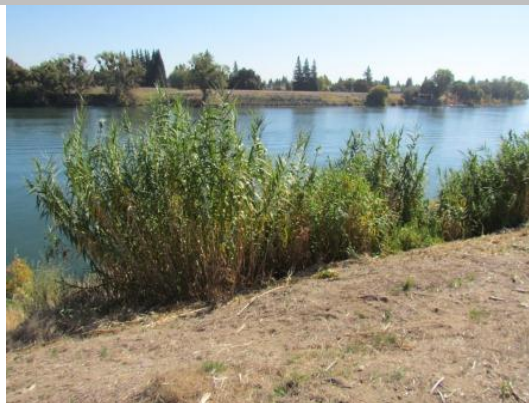
Photo 2 of 2 : SP\_2018\_RD0900\_230\_15\_20180301\_00008.jpg

View of arundo on the waterside of the levee looking downstream.

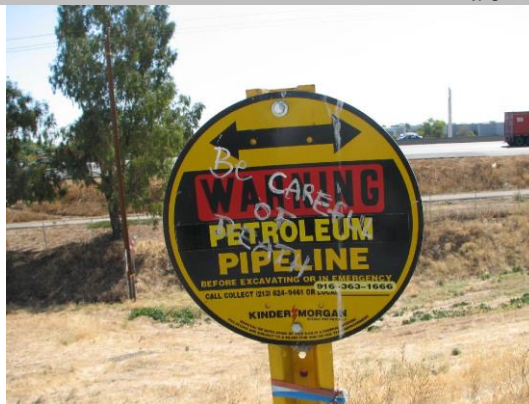
Photo 2 of 3 : UCIP\_SP\_2018\_41825\_72724.jpg

Marker of petroleum pipeline unable to confirm permit--there are 3 gas line in desk study records for gas line but none for Kinder Morgan.

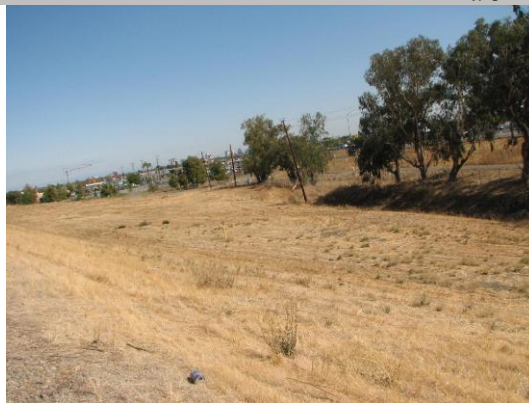
Photo 3 of 3 : UCIP\_SP\_2018\_41825\_72723.jpg

Additional marker visible on landward side--unable to confirm if line is tied to other marker near levee shoulder.

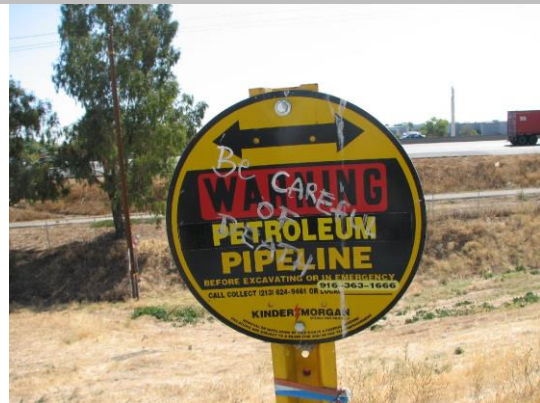
Photo 2 of 3 : UCIP\_SP\_2018\_41826\_72721.jpg

Marker of petroleum pipeline unable to confirm permit--there are 3 gas line in desk study records for gas line but none for Kinder Morgan.

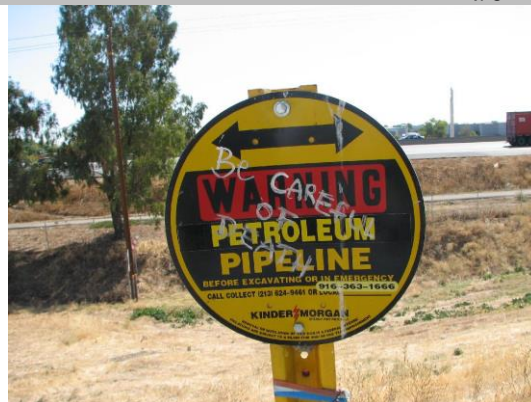
Photo 2 of 3 : UCIP\_SP\_2018\_41824\_72727.jpg

Marker of petroleum pipeline unable to confirm permit--there are 3 gas line in desk study records for gas line but none for Kinder Morgan.

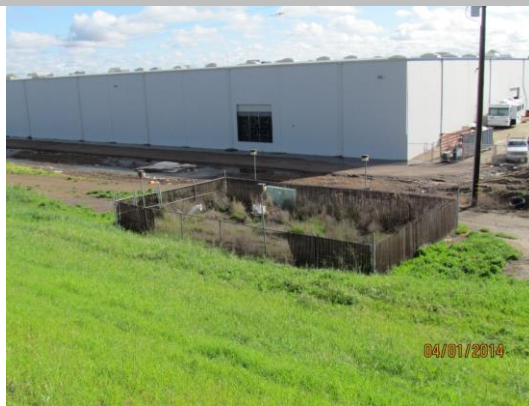
Photo 1 of 1 : SP\_2018\_RD0900\_231\_5\_20180301\_00001.jpg

View of the water well on the landside toe of the levee looking upstream.

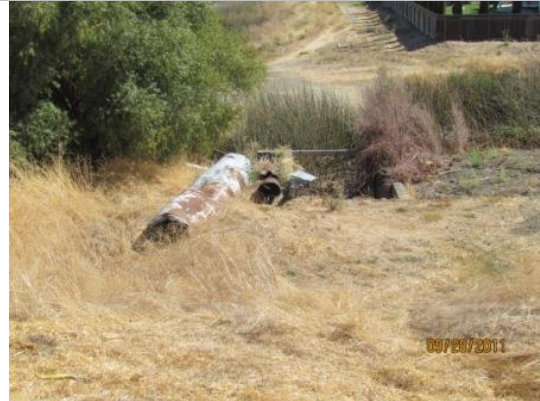
Photo 1 of 1 : SP\_2018\_RD0900\_231\_15\_20180301\_00002.jpg

Abandon pipes and debris was found on the landside of the levee looking upstream.

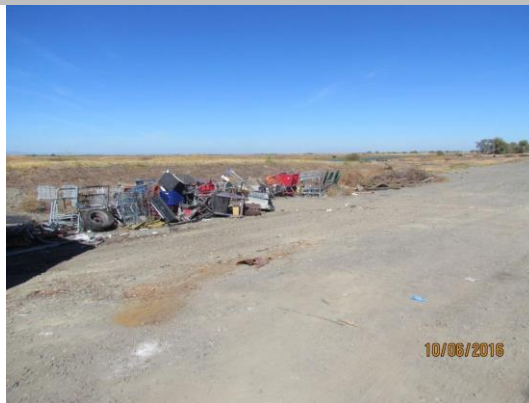
Photo 1 of 1 : SP\_2018\_RD0900\_231\_45\_20180301\_00010.jpg

View of debris on the landside shoulder of the levee looking upstream.
